United States Department of the Interior, National Park Service

National Historic Landmarks Property Name: WEST POINT FOUNDRY ARCHEOLOGICAL SITE

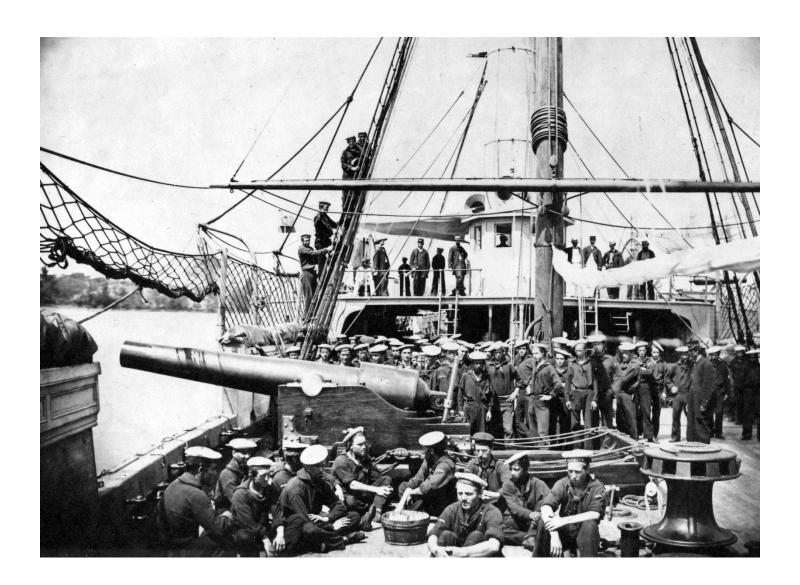
A 6.4-inch (16.3-centimeter) caliber, 100-pounder naval Parrott gun mounted aboard the sidewheel gunboat USS Mendota. Courtesy of Putnam History Museum. Used with permission.

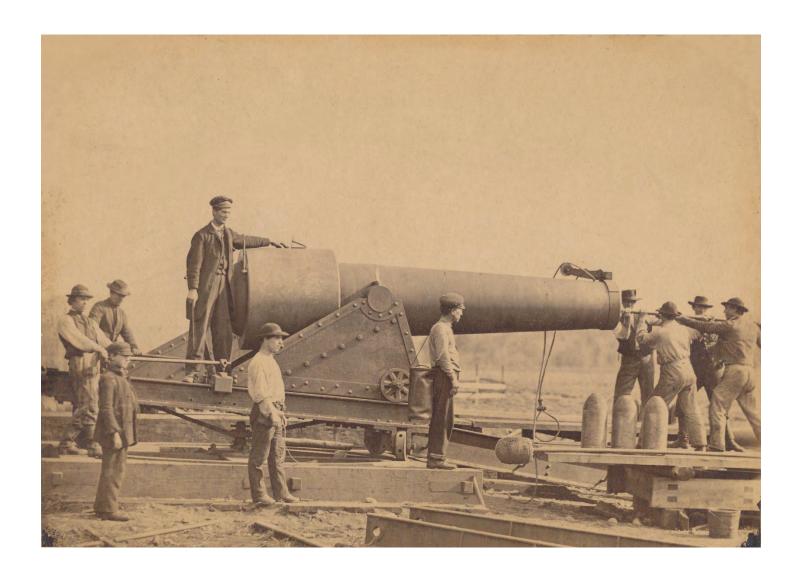
Figure 15. A crew prepares to test a 10-inch (25.4-centimeter) caliber, 300-pounder Parrott gun mounted on the West Point Foundry's testing platform (photograph dated May 1, 1864). Nearly two years earlier, President Abraham Lincoln witnessed a similar test conducted from this point. The remains of the testing platform would later be excavated and partly removed under the direction of Joel Grossman in the early 1990s. Courtesy of Putnam History Museum. Used with permission.

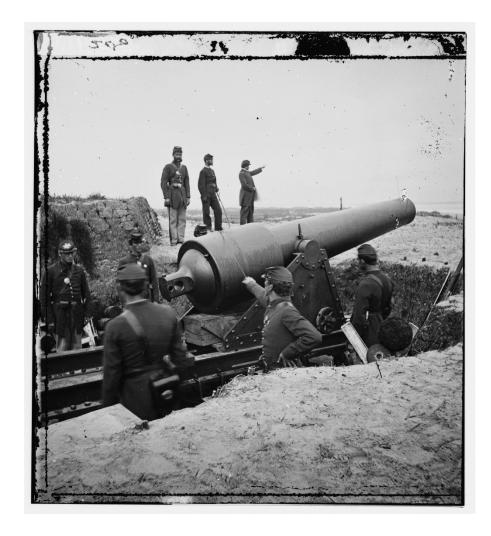
Figure 16. A gun crew demonstrates the firing position of an 8-inch (20.3-centimeter) caliber, 200-pounder Parrott gun, mounted in Battery Chatfield and aimed at Fort Sumter in Charleston Harbor. Courtesy of Library of Congress, Prints and Photographs Online Catalog - Civil War.

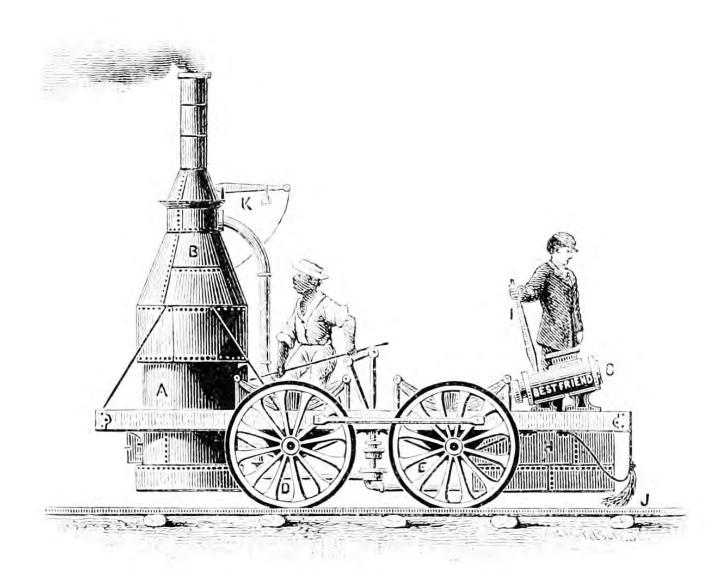
Figure 17. A later illustration of the steam locomotive *Best Friend of Charleston*, made by the West Point Foundry in 1830, the first American-made locomotive. Featured in *The Popular Science Monthly* 12 (January 1878): 270, fig. 34.

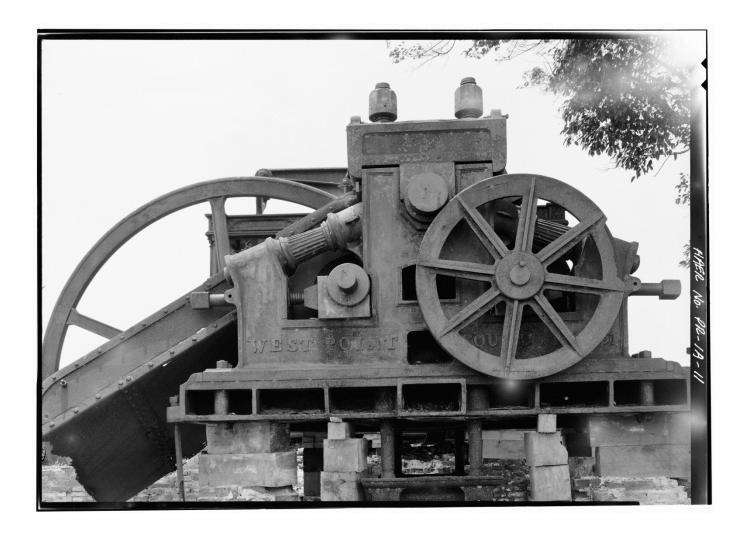
Detail of sugar-crushing equipment built by the West Point Foundry in 1861 for the Hacienda Figure 18. Azucarera La Esperanza in Manatí, Puerto Rico. See HAER PR-1A. Courtesy of Library of Congress, Prints and Photographs Online Catalog – HABS/HAER/HALS.

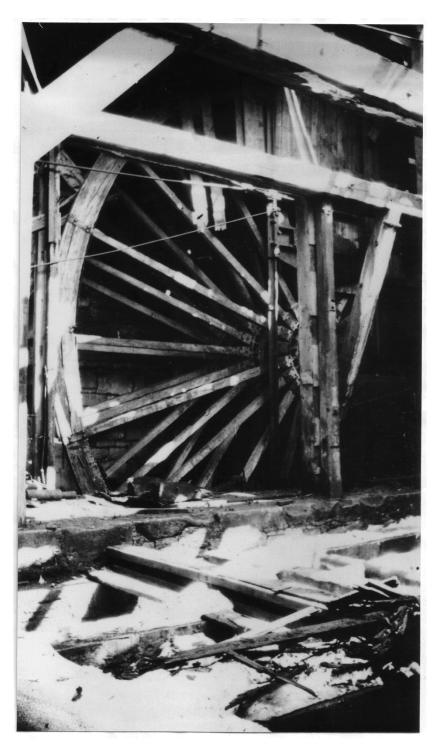
Figure 20. An undated view of the intact 36-foot (11-meter) diameter backshot waterwheel within the boring mill. The masonry wall partly obscured by the spokes of the waterwheel is visible in Photograph 1 near the center of the photograph on the far side of the waterwheel pit. Courtesy of Putnam History Museum. Used with permission.

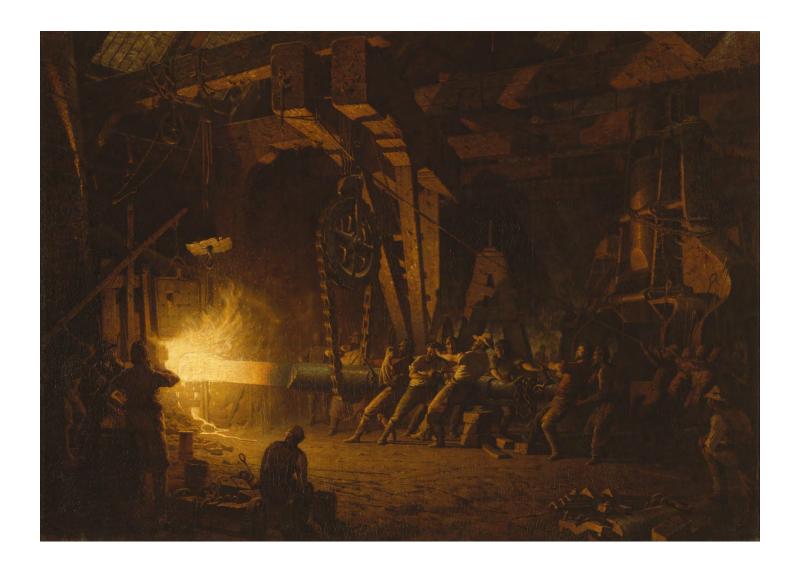
Figure 21. Forging the Shaft (1874–1877) by John Ferguson Weir (1841–1926). In this painting, Weir depicts the forging of a marine propeller shaft within the West Point Foundry's blacksmith shop. To the right is a steam hammer, possibly one of three depicted in the photograph in Figure 12. Oil on canvas. Courtesy of Metropolitan Museum of Art, American Paintings and Sculpture.

Photograph 8. Existing conditions of the interior of the blacksmith shop area depicted in Forging the Shaft (see Figure 21). Camera facing north. Photograph by Donald Burden.

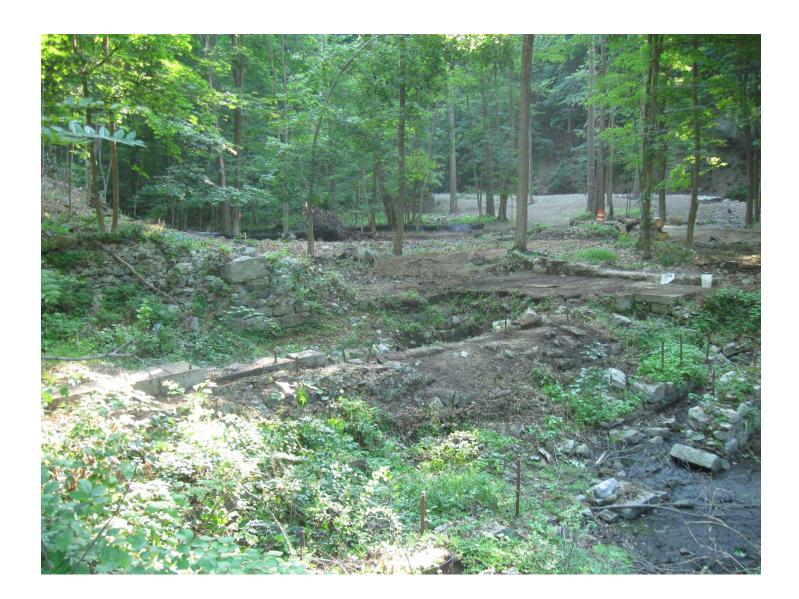
Photograph 1. Overview of the boring mill area in July 2012, with the waterwheel pit visible in the center to center-left. Camera facing northeast. Photograph by T. Arron Kotlensky.

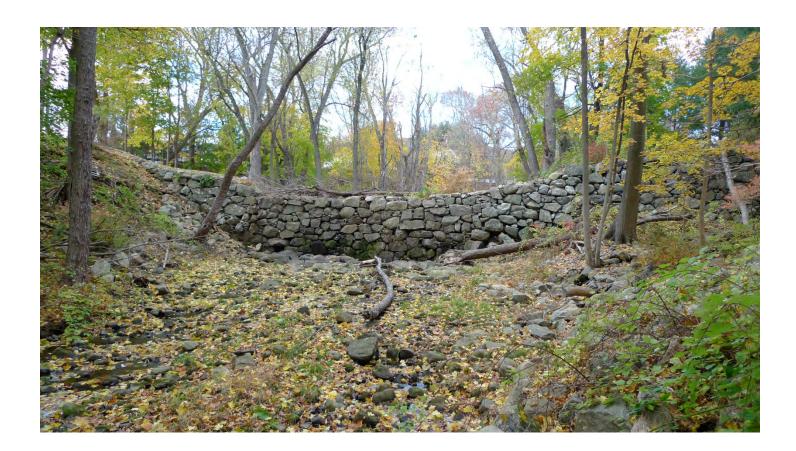
Photograph 2. View of the downstream face of the Upper Dam across Foundry Brook. Camera facing north. Photograph by T. Arron Kotlensky.

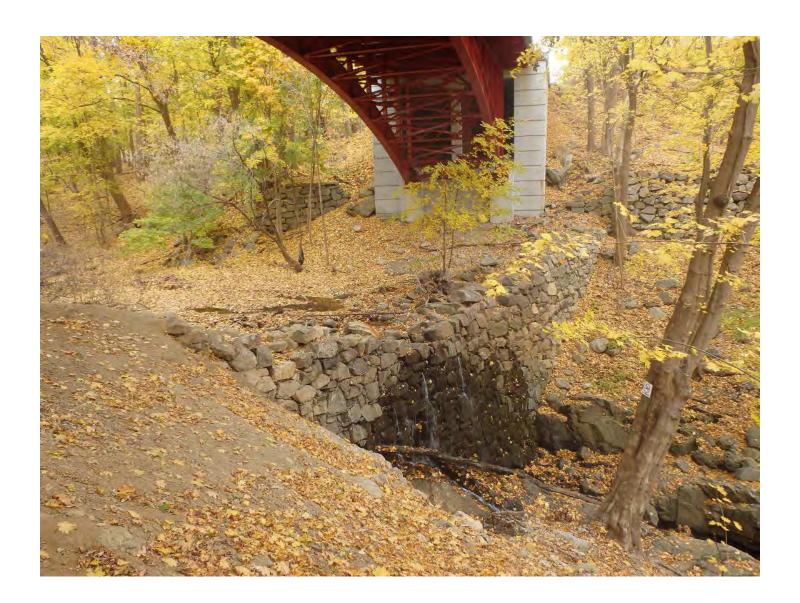
View of the downstream face of the Lower, or Main Dam across Foundry Brook, beneath Photograph 3. the present NY State Route 9D two-lane bridge. The abutment of the former bridge is visible left of the far abutment. Camera facing northeast. Photograph by T. Arron Kotlensky.

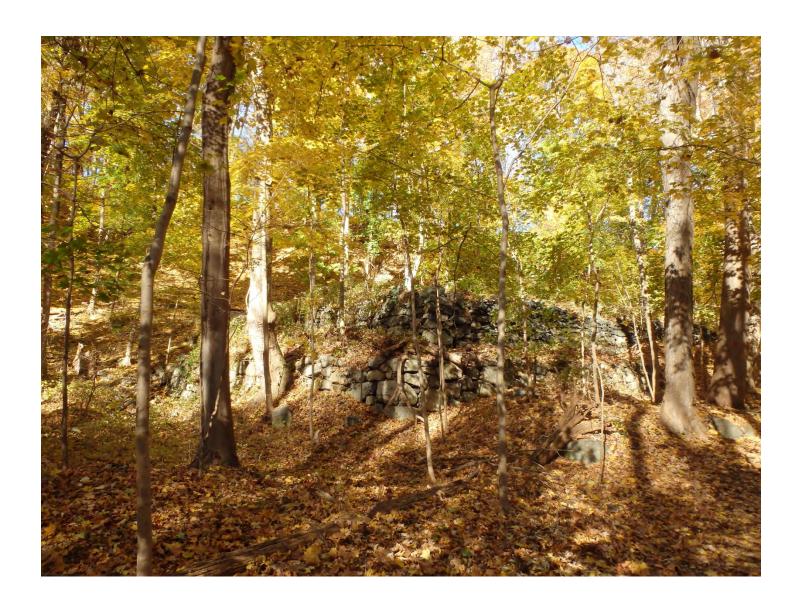
View of the southeast corner of Battery Pond, a stone-lined elevated reservoir between Photograph 4. the blast furnace and the blacksmith shop. Camera facing northwest. Photograph by T. Arron Kotlensky.

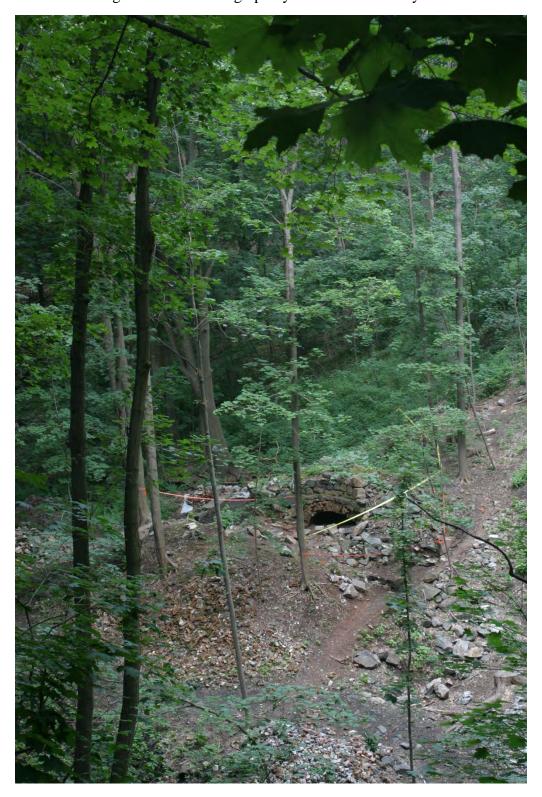
Photograph 5. View of the blast furnace area and surviving brick-lined west arch. Over 30 feet of the 40-foot tall stone stack has been salvaged but the remainder of the furnace remains intact beneath rubble and accumulated soil. Camera facing southwest. Photograph by T. Arron Kotlensky.

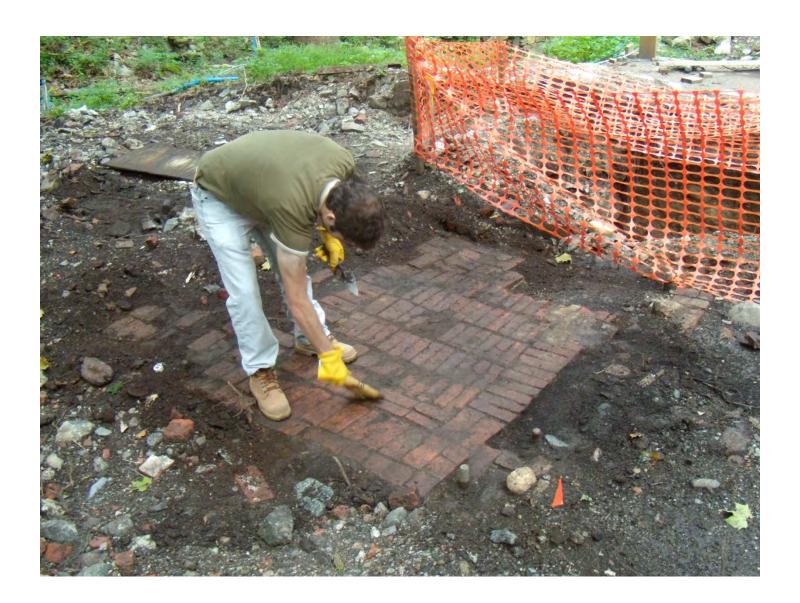
Photograph 6. Field personnel completing excavation of a brick machine pad in the boring mill area in 2012. Note the deposits of dark-brown oxidized swarf around the brick base as well as machine tie rods in the foreground. Camera facing southwest. Photograph by T. Arron Kotlensky.

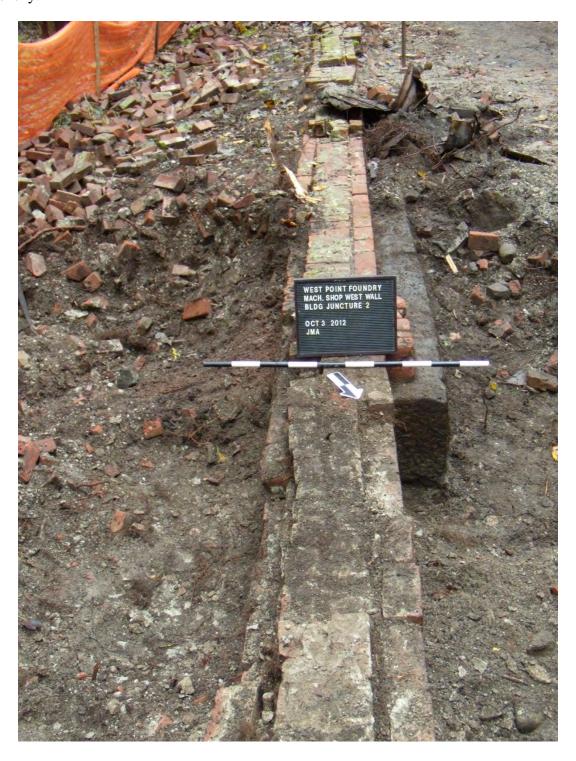
Photograph 7. Photograph of excavation in 2012 of the junction between the ca. 1839 machine shop addition and later 1853–1867 machine shop addition, demonstrating the intact deposits and working surface found within the interior of both buildings (left of the wall base). Camera facing southwest. Photograph by T. Arron Kotlensky.

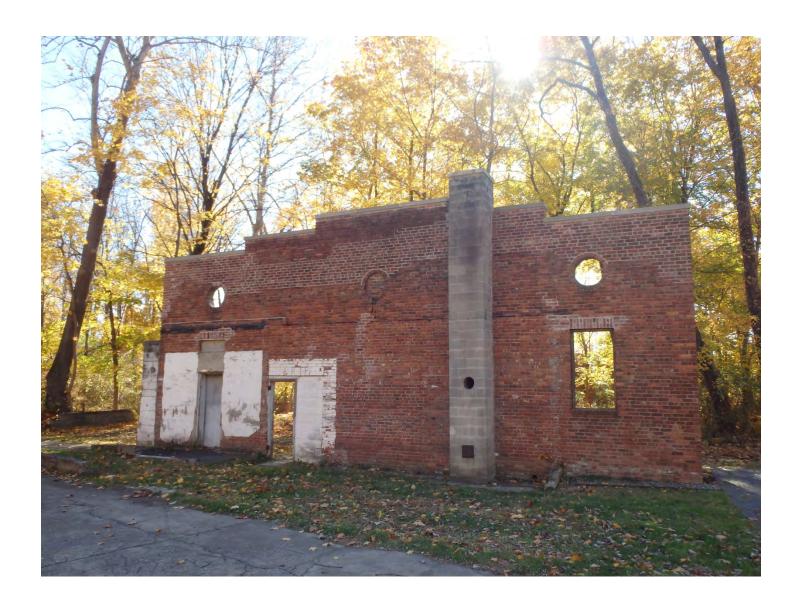
Photograph 9. Surviving northern elevation of the ca. 1853 pattern shop. The interior period view of the pattern shop featured in Figure 10 was captured south of the intact elevation. The concrete block chimney was added in the mid-twentieth century for a Quonset hut building that is no longer extant. Camera facing south. Photograph by T. Arron Kotlensky.

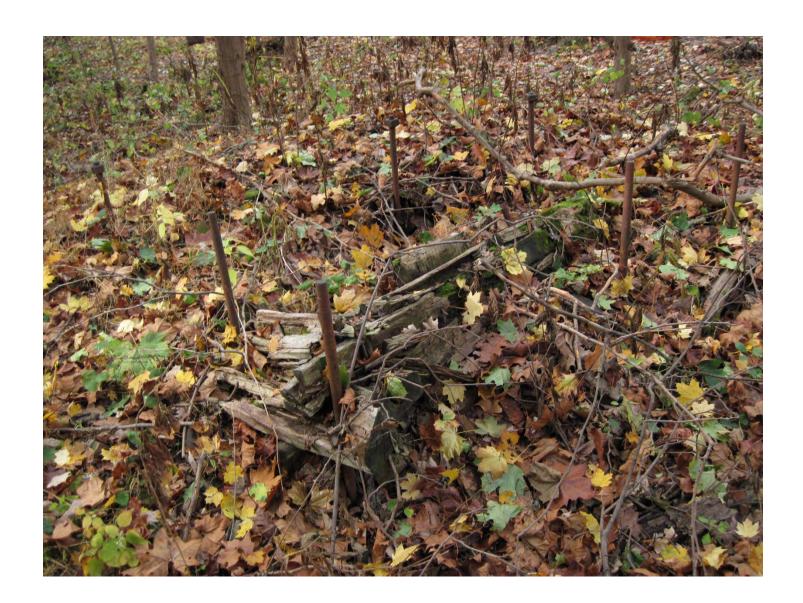
Photograph 10. Detail of machine tie rods and surviving timbers set within the machine shop area. Camera facing northwest. Photograph by T. Arron Kotlensky.

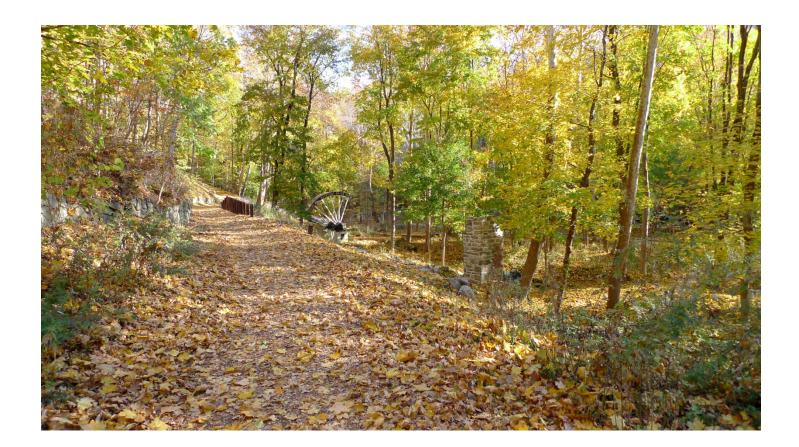
Photograph 11. Overview of the moulding shop area. The intact and repointed southwestern building corner in the center dates from the original moulding shop building built in 1817–1818. Camera facing northeast. Photograph by Donald Burden.

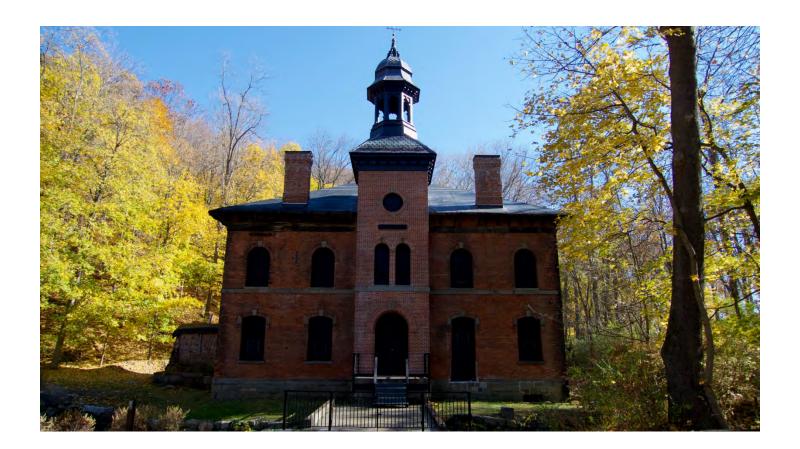
Photograph 17. The 1865 Office Building, built by the West Point Foundry at the close of the Civil War. In 2016, Scenic Hudson remounted the restored cupola on top of the building. Camera facing southeast. Photograph by Donald Burden.
